## HISTORIC PRESERVATION CERTIFICATION APPLICATION - PART 1

1. NAME OF PROPERTY: FI dikiti			
1. NAME OF PROPERTY:  Address of property Street 406 West		Maryland	21201
City_Baltimore, Co	Seton Hill	(National Register;	21201 9/30/75; Baltimore City
Name of historic district in which property if	Historic I	District; 7/15/68 & 8/	14/79
2 DESCRIPTION OF PHYSICAL APPEARANCE c - three architecturally turally significant earl altered continually from	their date of cor	which date from the difications. The indiversal distruction and within	idual structures were the last decade suffered
'midings are historica	lly and architectureuse of these but toric district whi persons.	ildings will preserve le providing specializ	District because the development of the the continuity of the ced, barrier-free housing (if known) late 19th c - mid 20th c
Name Accessible Housing Accessible Housing Accessible Street 518 N. Charles St.	Associates, Inc. c	/o Multi-Family Housin	
Street Baltimore		State_	MD Zip Code 21201

B-3866 Franklin Center 404-412 W. Franklin Street

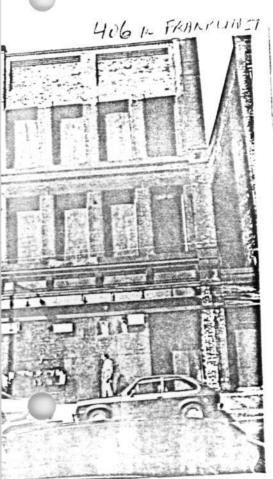
468 W FINERUM

joining the structures. 408 West Franklin Street is a three and a half story, four bay wide, late 19th century brick commercial structure with brown stone and molded brick details. some point, the fourth story was removed; the brick was painted; and the commercial storefront was inappropriately rebuilt. The metal cornice above the storefront comprises simple brackets, dentils, and recessed panels. The cornice will be restored. The storefront had been deteriorated and boarded, and the end brick piers had been rebuilt in a careless manner. The first floor is being reconstructed to reflect the former commercial character while accommodating the main entrance to the building and residential units on this floor. The first floor will comprise a brick base below two bronze-aluminum sliding windows with a fixed glass transom over each window; and metal and glass commercial storefront double doors with a single pane sidelight and a fixed transom above the door and sidelight. Decorative iron window guards will be installed across the windows. The walls surfaces will be covered with a buff color stucco. The window openings on the second and third floors are large and rectangular. The openings have been boarded and the original windows are missing. lintels and sills are brown stone and the bricks framing the window openings have a curved profile. There is a brownstone band with dentils between the second and third floors. The end piers project slightly from the facade wall and have molded brick blocks with a foliated pattern recessed which are being preserved. The half story remnant of the fourth floor is being refinished to a completed and useable fourth floor. The second and third floor openings will be preserved and replacement bronzealuminum slider windows with a fixed transom will be installed. The third floor lintels will be constructed of concrete tinted brown to match the brownstone on the building. The reconstructed fourth floor will have bronze-aluminum sliding windows,
